Field Service Bulletin No. 56

ADC Compact
Type 5145 / 100/101/140

Modification kits “C-clips Protection and Discharge Plate” and “Self-latching shaft at Feed Gate” applied to ADC Compact

printed in Germany 08 / 2002

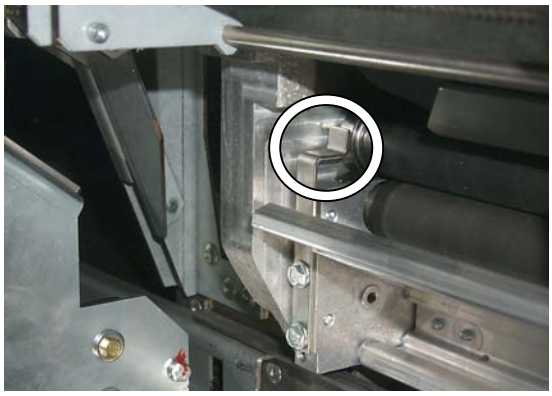
Incorrect reinsertion of scan rollers after cleaning causes broken c-clips and therefore a replacement of the complete slow scan unit is necessary. To avoid removal of scan rollers modification “C-clips Protection Plate” is introduced.

Protection plate has to be installed with the crank towards the scan roller. Modification kit includes four c-clips protection plates, for each side of both scan rollers.

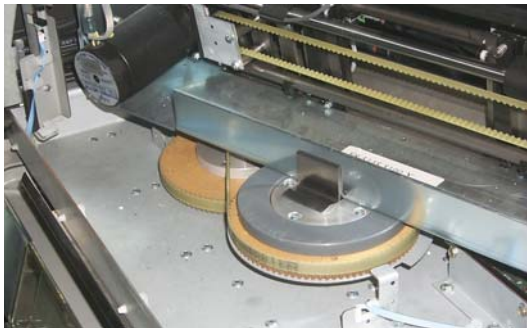
Discharge plate provides better grounding of the cassette unit and solves problems like, chip of cassette is not readable by the antenna.

Discharge plate has to be inserted in the middle of the rotation shaft.
